DEPARTMENT OF TRANSPORTATION**DIVISION OF ENGINEERING SERVICES**

Hinge-K Pipe Beam Assembly 102A-3: 11/23/09

a111-3 Forging to a110-3 Base Plate

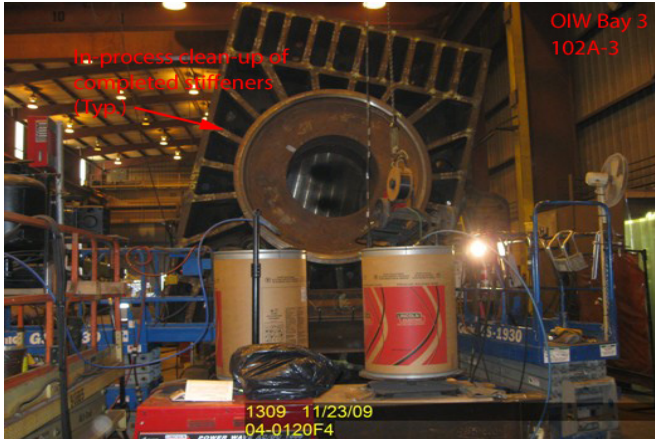
QA Inspector noticed that the partial joint penetration and fillet welds were previously completed, on the HPS 485W stiffeners and OIW production personell were in-process of performing weld clean-up and occasional FCAW on the weld joints, identified as WJ#'s W1-01 thru W1-163. QA Inspector spoke with QC Inspector Jose Salazar and Mr. Salazar explained that OIW welder #O6, Mr. Tim O'Brian and #T23, Mr. John Tellone were continuing to grind the weld start/stops, removing weld spatter and grinding all areas, which were previously marked by OIW QC Inspectors, per AWS D1.5 visual criteria and contract requirements. Mr. Salazar explained that minor underfill and a undersized weld had been previously measured on weld joints # W1-19 (piece mark c106/b106, 10mm fillet) and #W1-20 (c106/a107, 25mm fillet), that exceeded the limits of AWS D1.5 visual testing requirements and required FCAW fill passes. Mr. Salazar, explained to QA Inspector that QC was present during the FCAW repair and had recorded average, in-process welding parameters of 262 amps/26.2 volts, 10 i.p. m. travel speed, with a pre-heat temperature of approximately 400 degrees Fahrenheit (204 C). Mr. Salazar explained that 100% magnetic particle testing will be performed, on the above mentioned weld joint, after a minimum 48hrs. cooling time, per AWS D1.5. QA Inspector noted that the welding procedure specifications (WPS 3049) was utilized for the in-process repairs and QA Inspector noted that welding parameters/pre-heat

temperatures appeared to in compliance with the above mentioned WPS's. See attached picture below.
